# Experience with Unlined Pressure Shafts in Norway

by R. SELMER-OLSEN

Professor of Geological Engineering, the Technical University of Norway, Trondheim, Norway

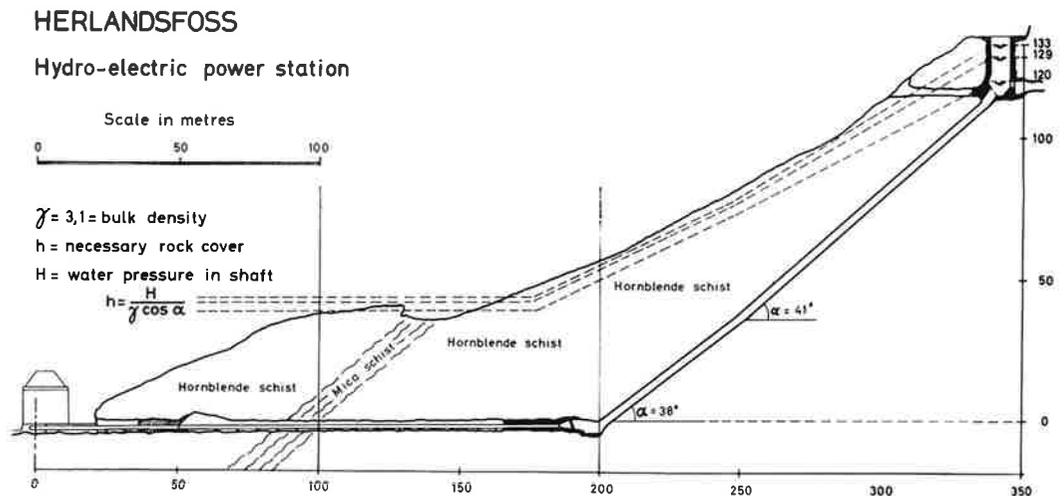
An unlined pressure shaft was designed for the Herlandsfoss Kraftverk, built around 1919. The shaft consisted of 2 parts: a pressure shaft dipping approximately 40°, and a horizontal pressure tunnel below approximately 140 metres long (Fig. 1). From the pressure tunnel, a lined (steel and concrete) tunnel leads into the station. The rock types in the area are hornblende schist and biotite schist.

When water pressure in the pressure tunnel reached 120 metres (measured from the roof of the pressure tunnel), the rock cracked at the spring-line over a distance of approximately 50 metres upstream from the lined part. The line for  $h = \frac{H}{\gamma \cos \alpha}$  for this head is drawn in Fig. 1. The cracked part of the pressure tunnel was lined with concrete, but when the water pressure in the pressure tunnel reached 129 metres, even the concrete lining cracked in the same area. The lining was reinforced concrete with a minimum thickness of 50 centimetres. Grouting behind the lining had been carried

out. This lining should – in addition to the weight of the overlying rock – have been able to sustain the water pressure. However, it seems reasonable to assume that the rock masses over the tunnel had been lifted during the first cracking, and then deformed downwards again as a plate over the tunnel.

line for  $h = \frac{H}{\gamma \cos \alpha}$  at this head is also drawn in Fig. 1.

That no failures occurred in the tunnel at a distance from 60–110 metres from the original lined part during the first two increases in head, may be ascribed to the competence and direction of the hornblende schist. The hornblende schist has few joints cutting across the foliation, dips parallel to the shaft, and has a strike nearly perpendicular to the shaft plane. Due to this, the tunnel section in question may have a certain extra load due to stresses mobilized from the rock further up the valley side. A quantitative value for this increase in stresses around the tunnel, however, is hard to estimate.

Fig. 1. Failure of unlined pressure tunnel – Herlandsfoss Kraftverk, 1919.

Lining was thereafter carried out near the foot of the shaft, and the water led into the station in a steel tube. No failures have occurred since, even under pressures up to 130 metres above the roof at shaft bottom. The

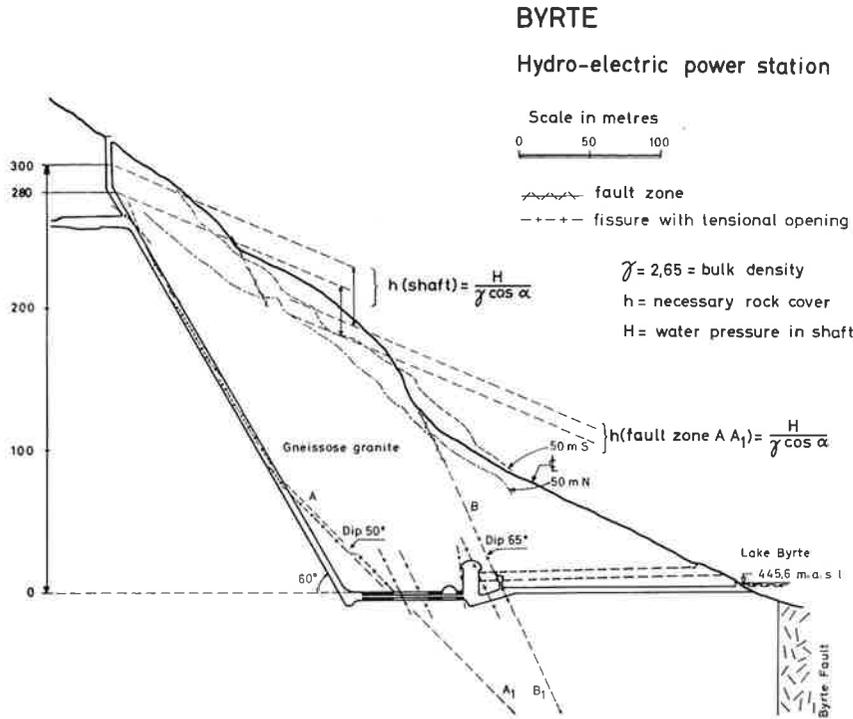
Fig. 2. Failure of unlined pressure shaft – Byrte (Tokke 5), 1968.

The pressure shaft in question has a dip of 60°. The rock type is gneissose granite ( $\gamma \approx 2.65$ ). Several systems of joints and minor faults occurred with strike approximately parallel to the valley side. The dip is usually between 55° and 70°. No failures were registered when the water pressure for two months was held below 280 metres, measured from the bottom of the unlined shaft. (This corresponds to 720 metres above sea level.) A little leakage, however, was registered. The line for  $h = \frac{H}{\gamma \cos \alpha}$  is in this instance quite close to the surface, but for the lower part of the shaft a little higher (Fig. 2).

leakage increased somewhat. However, when the following month the head was rapidly raised 20 metres, the rock in the shaft and in the power station area cracked according to the line given in Fig. 2. The line for  $h$  at this water pressure is also drawn. It is seen that it lies considerably over the terrain.

It must be mentioned that sealing of the fault zone  $AA_1$  was carried out before the shaft was filled up, but with rather unsatisfactory results. It is therefore reasonable to assume that this zone had sufficient permeability to allow a build-up of a cleft-water pressure corresponding to the full water pressure in the shaft.

The opening of the small clay-filled fault zone  $AA_1$  that followed the cracking of the shaft probably led to an increase in cleft-water pressure and opening of the zone  $BB_1$ . The opening of these two zones seems to indicate that the whole rock mass outside the zones

has been somewhat moved towards a wide clay-filled fault (Byrte fault) outside the tail race tunnel.

It may be concluded that the directions of the faults and joints were particularly unfavourable in this case. However, some sufficiently unfavourably orientated faults or joints may certainly occur in all rock masses, even if the most careful investigations have been carried out at the planning stage.
